Longdowns Pedestrian crossing facilities

Feasibility Report

File no EDG2038

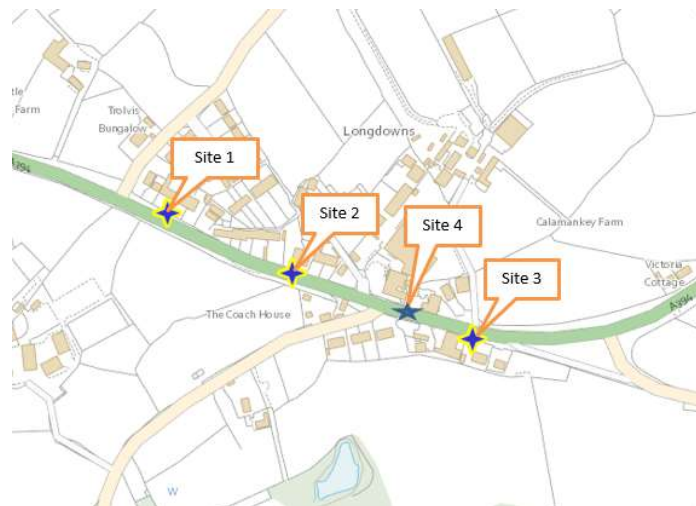
Image 2 showing where speed monitoring equipment has been deployed in 2014

2.3.1 Three speed monitoring devices were deployed soon after the introduction of the 30mph speed limit in 2014. The locations of these are shown in Image 2 with Table 1 showing the data obtained. Speed data was also collected in September this year and this is also shown in Table 1 as Site 4.

2.3.2 Speed data indicates that westbound traffic speeds are higher than eastbound speeds and that speeds are higher near the Glenmore Terrace junction. Speed readings near the junction are higher for westbound traffic, perhaps because the speed limit, to the west of the junction, soon changes to 50mph.

Covert speed monitoring using RadarClass			
	Eastbound	Westbound	Date
Site 1			
Mean (mph)	31.5	36.9	May-14
85th%ile (mph)	37	42	May-14
Site 2			
Mean (mph)	27.6	34.5	May-14
85th%ile (mph)	31	39	May-14
Site 3			
Mean (mph)	29.6	33.3	May-14
85th%ile (mph)	35	38	May-14
Site 4			
Mean (mph)	26.1	29	Sep-21
85th%ile (mph)	30	33	Oct-21

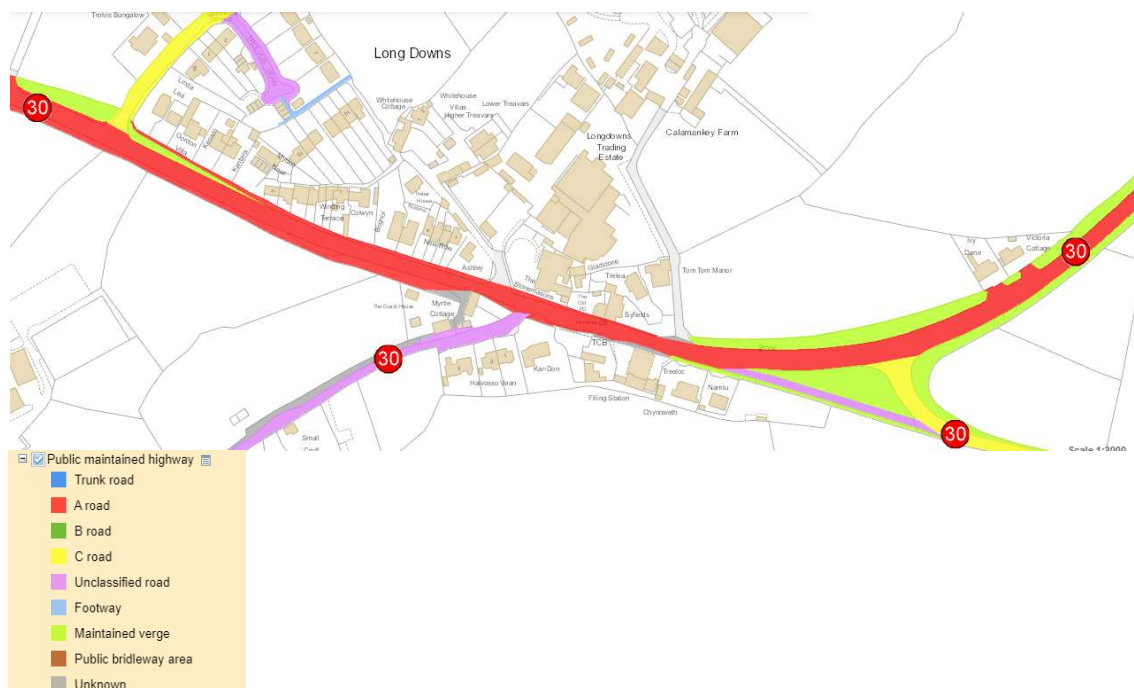
Image 4 Showing areas of public maintained highway.

2.5.1 Initial investigations have been made to identify land ownership within the vicinity of considered works. Cornwall Council Intranet mapping indicates that land, to the sides of the A394 through Longdowns is predominantly s publicly maintained highway (see image 4)

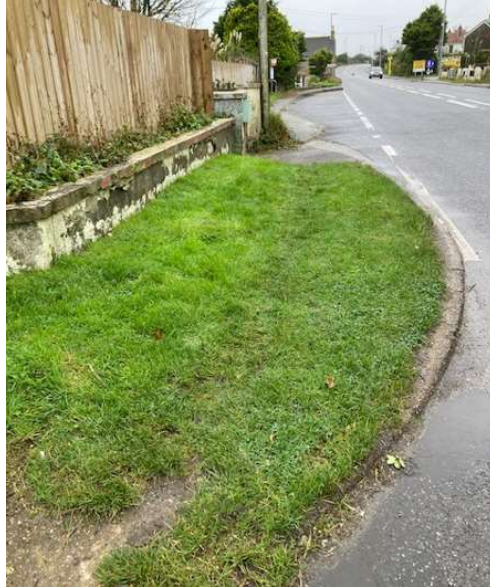
Image 6 showing area of grass verge to the east of the garage forecourt

10.1.1 There is an area of verge just to the west of the garage forecourt. It is evident that pedestrians use this area to walk along see Image 6.

10.1.2 Cornwall Council mapping shows this area to be public maintained highway. To aid pedestrian movement it is suggested that this area is made into footway to aid pedestrian movement as grass verge areas often become muddy and slippery underfoot.
